STUDY OF CLAY SHALE SLOPES

ARMY ENGINEER WATERWAYS EXPERIMENT STATION VICKSBURG, MISSISSIPPI

OCTOBER 1971

MISCELLANEOUS PAPER S-71-22

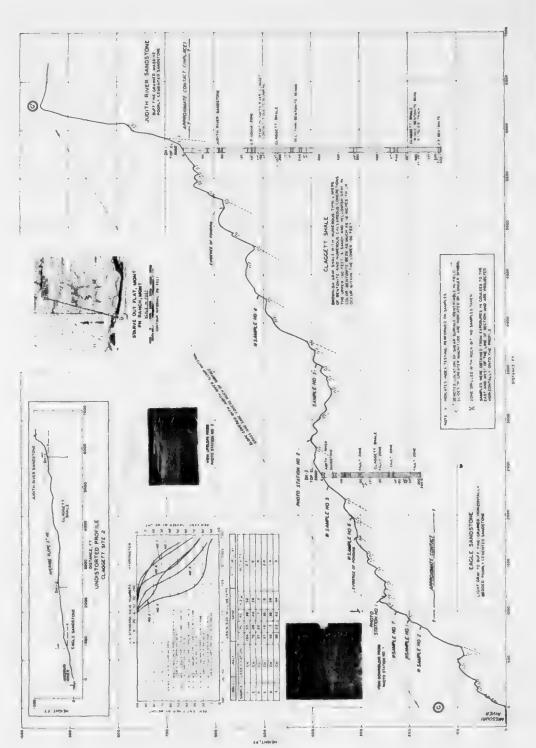
Fig. 2. Claggett site 2, geologic section G-G'.

and while overall slope heights amounted to several hundred feet, inclinations were typically very low (5 to 10 deg), for example, Fig. 2. Excavations into these materials have usually exposed old failure surfaces, on which renewed sliding occurred. Slickensides were especially common in these three materials. Cementation was minimal, with the exception of parts of the Pierre. Slope inclinations in these three materials are comparable to their residual angles of internal friction. Where the Judith River sandstone formed a rigid base. certain slopes in the Bearpaw stood slightly steeper than elsewhere. Slope failures in the Colorado group, also a marine deposit of Late Cretaceous age, were relatively uncommon. Where they occurred, sliding appeared to involve a single failure, for example Fig. 3. Cementation was fairly well developed in the Colorado group; and probably as a result thereof, slope inclinations in the unit commonly were steeper than the residual angle of internal friction of the materials. Slickensides were present but not common. The Paleocene (lowermost Tertiary) Fort Union group, composed of one marine and two nonmarine formations, generally stood less steeply and showed more failures than the Colorado group, but stood steeper with fewer failures than the Claggett, Bearpaw, and Pierre formations. Notably, there were wide intraformational as well as the interformational differences within each of the five geologic units studied. Bentonitic layers with high plasticity characteristics, high swelling potential, and low residual shear strength were found in all of the units.

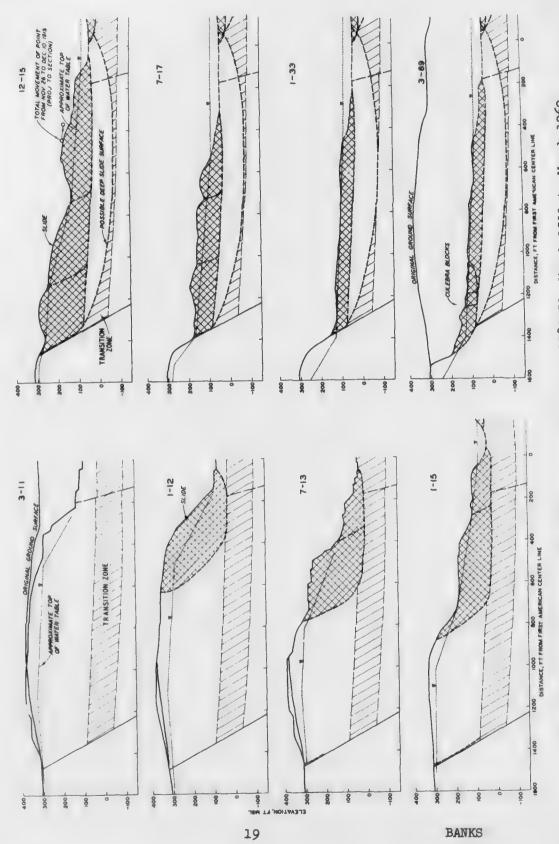
Fig. 11. Development of East Culebra slide at sta 1782+50, March 1911 to March 1969.

The slides grew significantly from 1908 to 1914 by deepening in pace with excavation and progressively incorporating new blocks of ground farther back in the bank. By 1911 slides had occurred in both banks at intervals between sta 1760 and 1794. As the final excavation bottom at el +40 was reached in 1913, the East Culebra slide had attained a depth corresponding approximately with the top of the transition zone in the Cucaracha formation. Sliding was apparently taking place along one or a few favored stratigraphical horizons. Cracking of the bank usually preceded failure. Then after a few months the blocks separated by cracks gradually settled, sometimes also tilting toward

Sliding activity accelerated on the east side to a major break in 1914 almost a year after the canal was flooded for dredging. By January 1915, the West Culebra slide was divided by long cracks along geological fractures into several potentially unstable blocks. The blocks evolved to graben and horst structures as the mass crept slowly canalward. In August and September 1915, both slides converged in massive failures accompanied by upheaval of the canal bottom and blockage of the canal. An example of the reconstructed history of sliding for one section in the East Culebra slide is shown in Fig. 11.

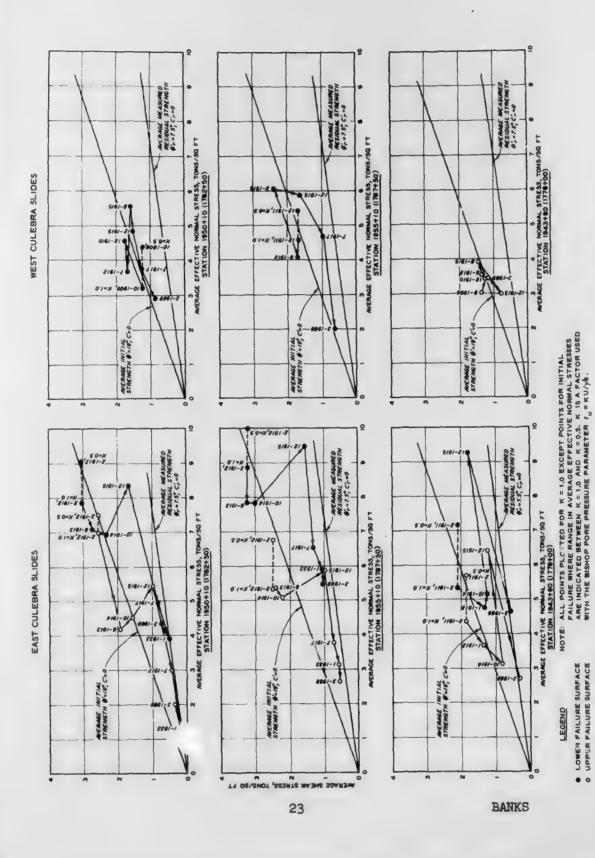
Average stresses from analyses of East and West Culebra slides. Fig. 12.

East Culebra and West Culebra Slides. Cross sections of the slopes were reconstructed at selected times (see as an example Fig. 11) for stability analyses. The average strength at the time of first-time failure and the variation in average strength with time are of particular interest. Possible deep critical failure surfaces and failure surfaces corresponding to present slope indicator data were used to determine the peak effective strength, but the effect of assumed depth of sliding was small. The effect of reduced pore water pressure was also considered. Stability analyses of initial failure conditions at selected sections along the canal indicated an average effective strength envelope of \emptyset' = 19 deg and $c' \approx 0$ (Fig. 12). The friction angle thus determined compares closely with friction angles determined from test results. Analyses of failure conditions for various dates of sliding indicated that the average shear strength between the time of initial failure and the massive movements (Oct 1914 for the East Culebra slide and Aug 1915 for the West Culebra

slide) remained high and near the strength envelope determined for initial failure despite the large movements that occurred. Analyses of failure conditions subsequent to the time of massive movements to the present indicate a large reduction in required shear strength (Fig. 12). In most cases the required shear strength was slightly higher than the average residual strength from laboratory tests. This is consistent with continued slope movements occurring in the East Culebra and West Culebra slides.
